POTOMAC CREEK NO. 1

STAFFORD COUNTY, VIRGINIA

VA. NO. 17902

PHASE I INSPECTION REPORT NATIONAL DAM SAFETY PROGRAM

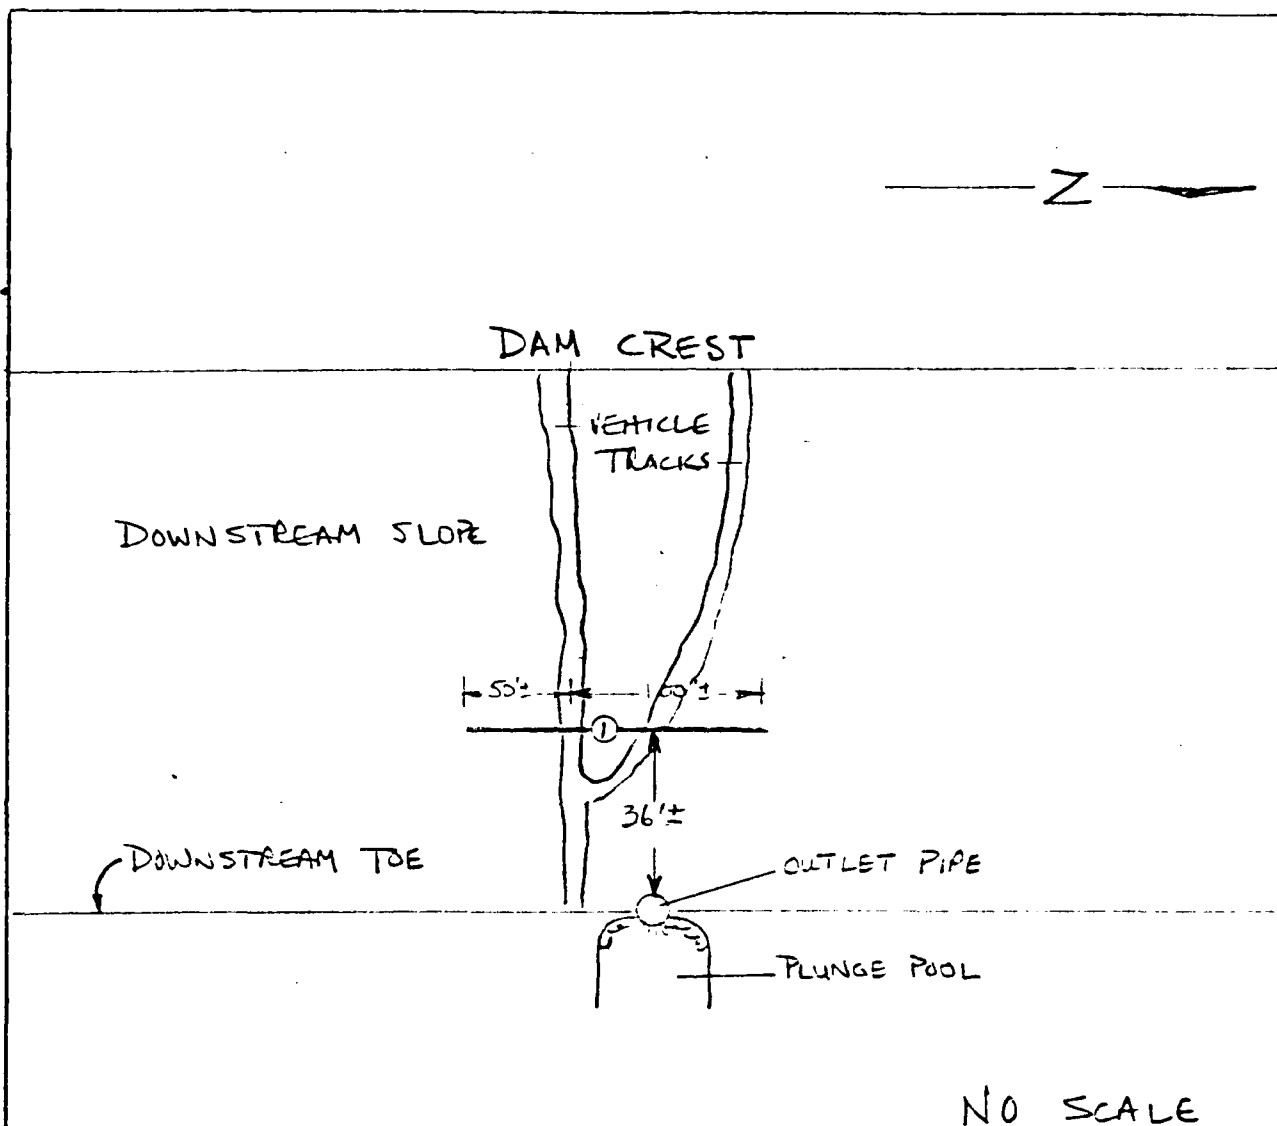
SHEET NO 1 OF 1
JOB NO. Y80105

The continuous, wet or marshy area observed along the downstream slope is not believed to represent seepage through the dam because an internal drainage system exists for this structure and particularly since the lake level was 25 ft[±] below normal pool level at the time of inspection. It is likely this area is the result of accumulated surface runoff. It is recommended that this area be observed in future SCS inspections and during normal maintenance operations to verify that this zone does not represent seepage through the dam.

① THIN SATURATED ZONE 2'± WIDE
AND 150'± LONG

g) The thin saturated area present on the downstream slope should be monitored during normal maintenance operations, particularly once normal pool levels are resumed, in order to verify that this condition is not related to seepage passing through the dam. If increased saturation or flow should occur, a professional Geotechnical Engineer should be contacted to evaluate the problem and make recommendations for required corrective measures.
